Structural Damage Identification in Stiffened Plate Fatigue Specimens Using Piezoelectric Active Sensing

B. L. GRISSO, G. PARK, L. W. SALVINO and C. R. FARRAR

13. SUPPLEMENTARY NOTES See also ADA580921. International Workshop on Structural Health Monitoring: From Condition-based Maintenance to Autonomous Structures. Held in Stanford, California on September 13-15, 2011 . U.S. Government or Federal Purpose Rights License.

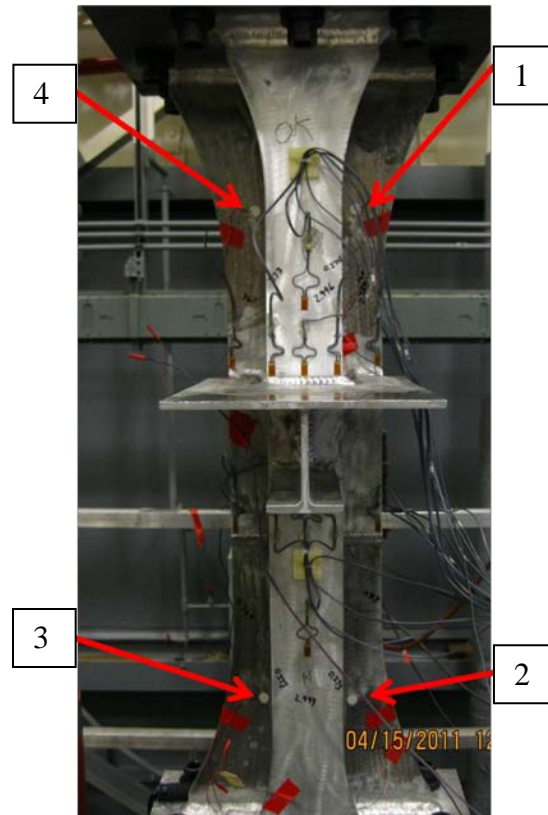
Figure 1. The front of the specimen is shown and the four piezoelectric discs bonded to the plate are labeled.

In this study, the test structures are aluminum fatigue specimens constructed with typical Navy ship design details (Figure 1). Each of these medium sized specimens consists of a single stiffened plate at the location of an intersecting stiffened bulkhead, which provides stress concentration, and therefore crack initiation, sites. All connections are welded. The base plate and bulkhead material consist of 3/8 and 1/4 inch thick 5083-H116 aluminum, while the stiffeners are made of extruded 6061-T6 aluminum. Thick end plates are welded to the specimen to allow for placement of the plate in a tensile fatigue machine. Using the fatigue machine, different loading profiles are applied to groups of specimens in an effort to characterize the S/N curve for this type of plate intersection. The results from monitoring one of these stiffened plate specimens are presented in this paper. Sixteen strain gauges were applied to the specimen to assist in balancing the structure in the fatigue machine, as well as monitor the loading through the fatigue process.

As seen in Figure 1, four piezoelectric transducers were bonded to the surface of the base plate. Each transducer is a 0.5 inch diameter, 0.02 inch thick disc made of 851 material from APC, International and was bonded to the plate with Vishay Micro-Measurements M-Bond 200 adhesive. An Acellent Technologies Inc. Smart Suitcase Lamb wave data acquisition system was used to actuate each piezo and record the response at each of the three other piezos in order to measure all the propagation paths

Figure 1) in one direction, and was less than an inch away from the other edge. The crack length described at the Lamb wave measurement cycle counts is described in Table 1.

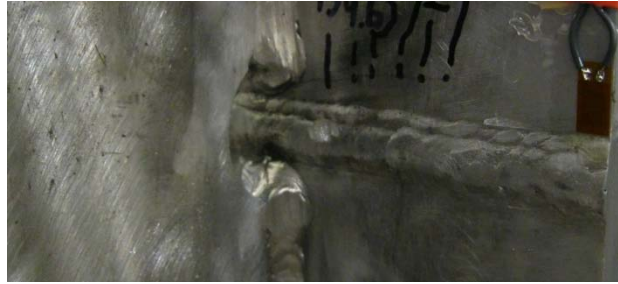
Figure 2. The front of the specimen shows the butt weld and rathole where crack initiation occurs.

As the fatigue test progressed, a crack was initially observed at 167,300 cycles. The crack was located in the heat-affected zone adjacent to the main plate butt weld. The crack started in the center of the plate, directly under the rathole in the stiffener. A rathole feature (seen in Figure 2) allows for the stiffener to be welded to the plate without having to grind the butt well flush with the plate surface. As previously mentioned, the test was not terminated due to the initiation of a crack, but allowed to continue. The crack grew through the plate thickness to the back of the specimen, and then along the butt weld towards the free edges of the test specimen. Figure 3 shows the crack in the back of the plate with the length of the crack identified at different cycle counts. Eventually, the crack extended completely to the edge (right side of

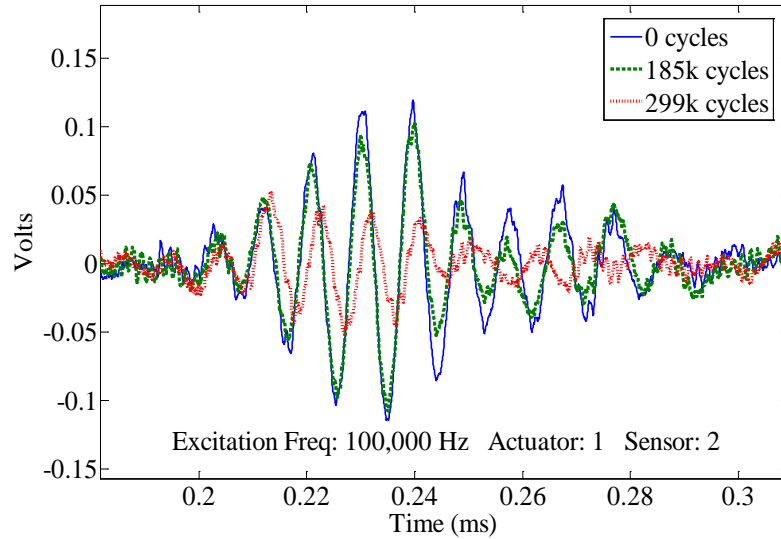
Figure 4. The isolated A_0 mode first arrival, recorded at PZT 2, is shown at 3 different fatigue levels.

As mentioned in the previous section, the PSD analysis was applied to the first arrival of the first asymmetric mode. In Figure 4, the A_0 mode is isolated in the time domain for 100 kHz excitation generated at piezo 1 and measured at piezo 2. As the crack grows across the stiffened plate, changes to the waveform can be visually observed. The signal with the largest amplitude was acquired before any fatigue testing began. By 185,601 fully reversed cycles, attenuation of the curve is clearly noticeable. After 299,296 fatigue cycles, there is a significant difference in amplitude as well as a phase delay.

After applying the PSD analysis to the waves seen in Figure 4 (as well as the rest of the data described in Table 1), charts were generated to describe the average recorded signal power as a function of the number of fatigue cycles. Figure 5 displays one of these bar graphs for 100 kHz excitation measured on the path from piezo 1 to piezo 2. Each bar represents an average power calculation, and two measurements are shown for each of the data sets described in Table 1 (i.e. the first two bars correspond to the measurements acquired with no cycling, the next two correspond to 1,000 cycles, and so on).

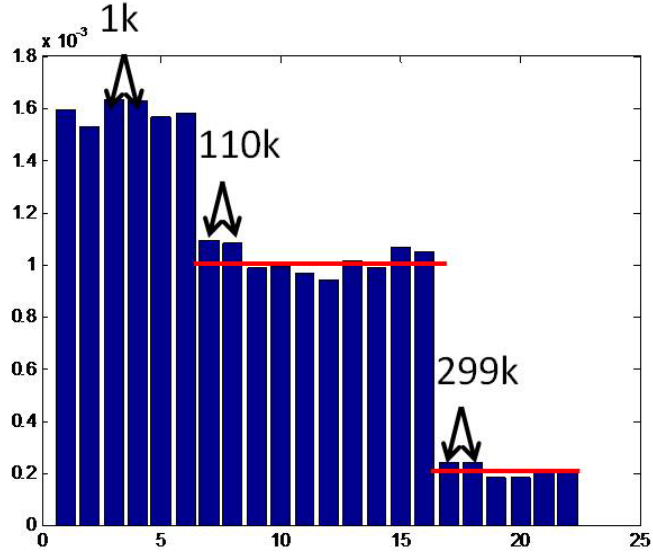
Figure 5. The area under the PSD curve, calculated twice at each fatigue level, is shown for the path from piezo 1 to 2 at an excitation of 100 kHz.

As seen in Figure 5, there are two distinct energy levels that happen along this path from 1 to 2. At the measurement taken at 110,452 cycles, there is a significant decrease in the signal power. This power level generally remains constant until 299,296 cycles when there is another large decrease in signal power (as visually observed in Figure 4). These dramatic power reductions at the sensor are likely caused by two distinct fatigue stages of the specimen. As previously mentioned, the crack was first visually observed at 167,300 cycles. This Lamb wave technique is

likely showing changes in energy at the onset of cracking before it can be felt or visually detected, indicating the presence of imminent damage. By 299,296 cycles, the crack was near four inches in length and directly in the path between piezos 1 and 2, thus severely limiting the amount energy transfer along that path. The PSD average power calculated along path 3 to 4 shows similar results.

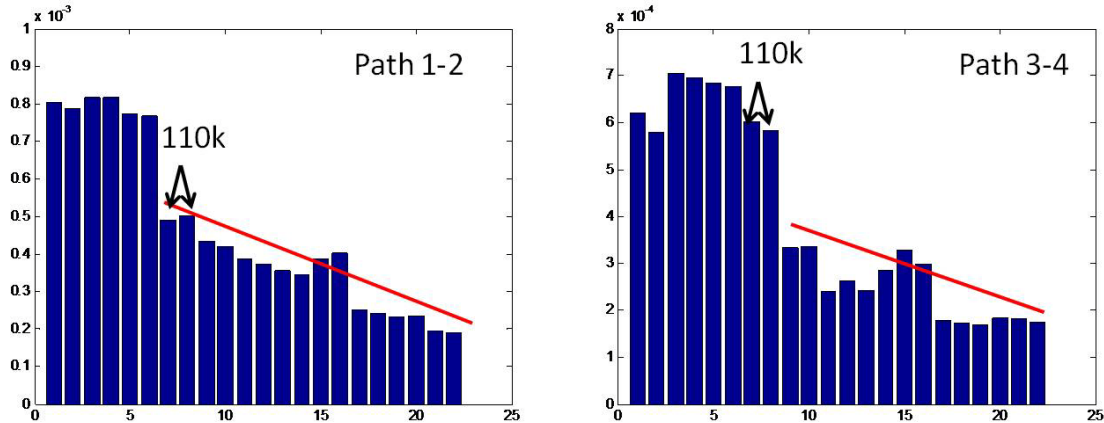
Figure 6. The area under the PSD curve displayed for the paths between PZT 1 to 2 (left) and 3 to 4 (right) at an excitation of 150 kHz.

While the 100 kHz results provide an indicator for the onset and extension of damage, the frequency was not able to track the crack growth. However, a higher frequency should be more sensitive to smaller changes in the amount of damage. Presented in Figure 6 are the average powers calculated for paths 1 to 2 and 3 to 4 at an excitation of 150 kHz. At this frequency, the onset of damage is again indicated at

the measurements taken at 110,452 cycles (except for path 3 to 4). However, instead of a constant power level until the crack extends to directly between the transducers, the energy gradually decreases as the crack grows. With this higher frequency, the growth of the crack can be consistently tracked by monitoring the signal power.
